FINAL REPORT
WESTBANK ASBESTOS REMOVAL PROJECT
NEW ORLEANS, LOUISIANA

RAPID RESPONSE CONTRACT NO. DACW45-94-D-0054
DELIVERY ORDER NO. 29
IT PROJECT NO. 768209

Prepared for:
U.S. ARMY CORPS OF ENGINEERS
OMAHA DISTRICT
P.O. BOX 13287
OMAHA, NEBRASKA 68113

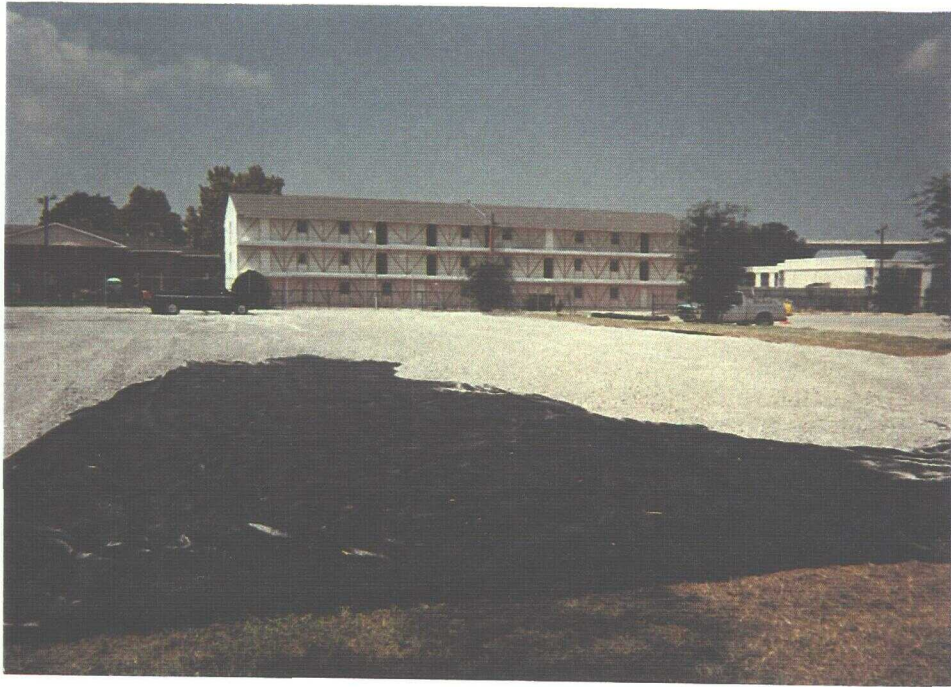
Rock Placement at Command Post

An area approximately 300 feet by 300 feet was covered with geotextile material and then covered with approximately six inches of limestone. As the project progressed, the covered area was expanded approximately 100 feet to the south to provide additional space.

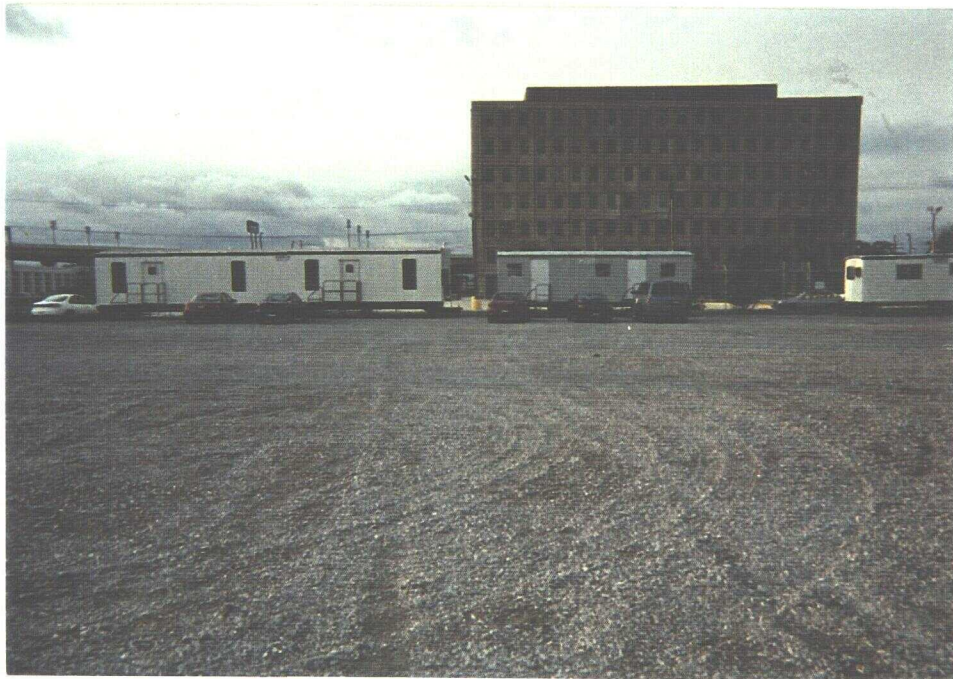
Trailer Placement at Command Post

Three office trailers were placed along the north edge of the yard adjacent to the north fence line, one for the USEPA/START team, one for USACE/IT, and one for the use as a public relations trailer. The trailers were set and anchored according to the local requirements. Portable steps were placed at each doorway. Figure 1 details the initial layout of the command post.

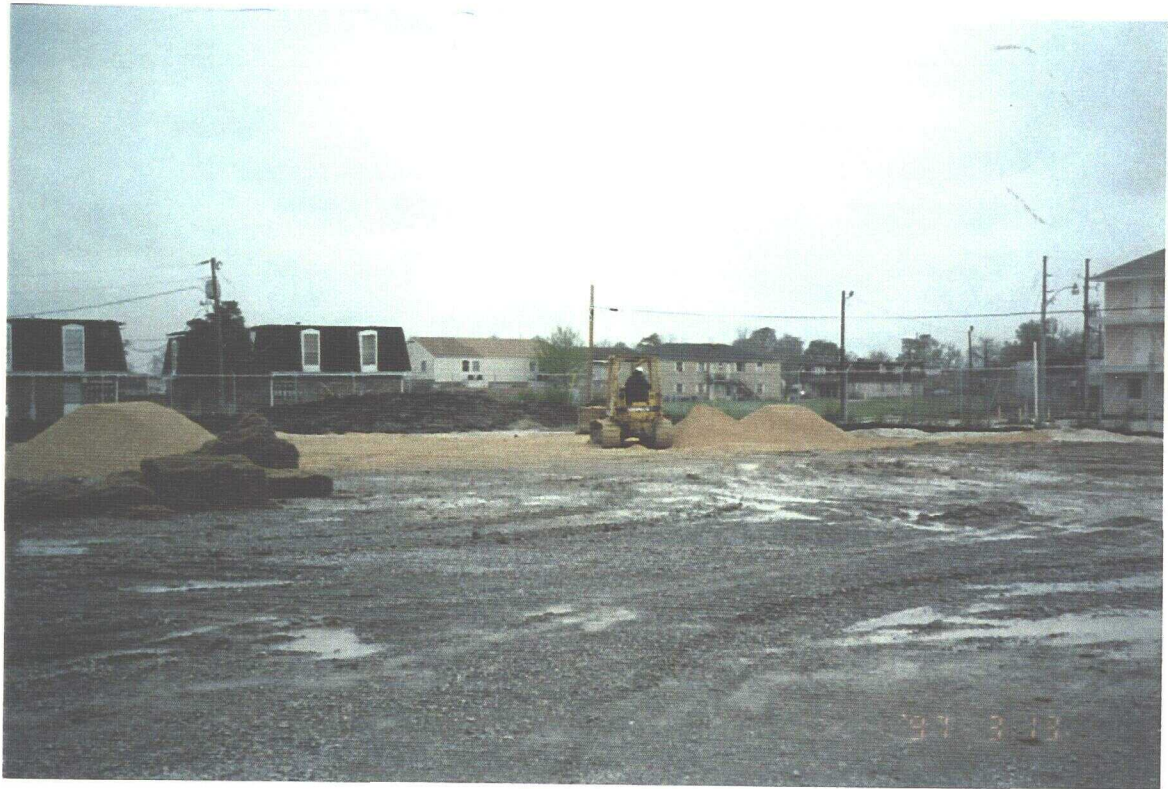
Expansion of Command Post

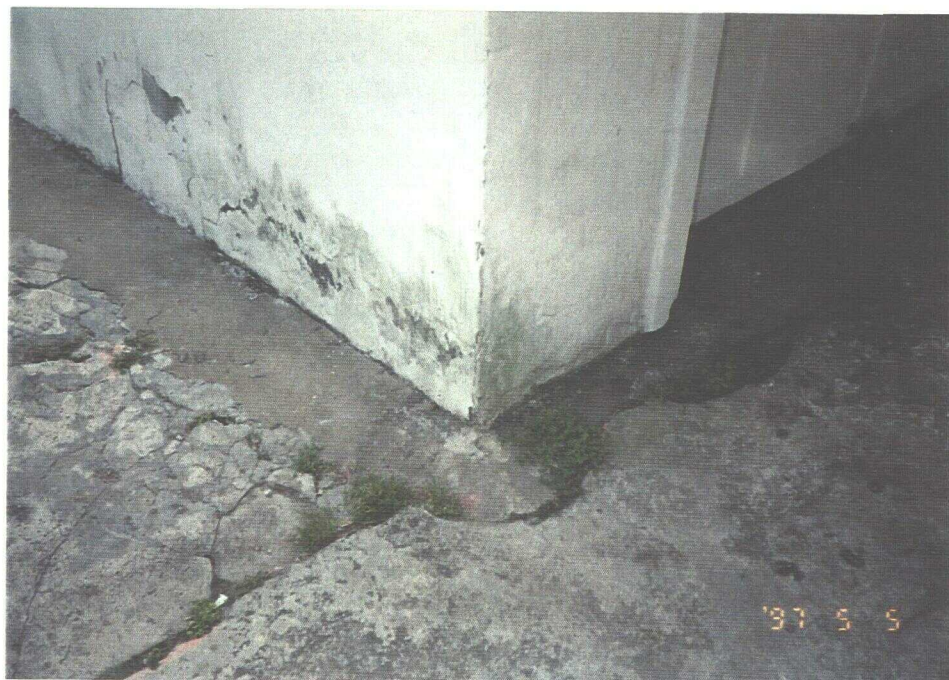
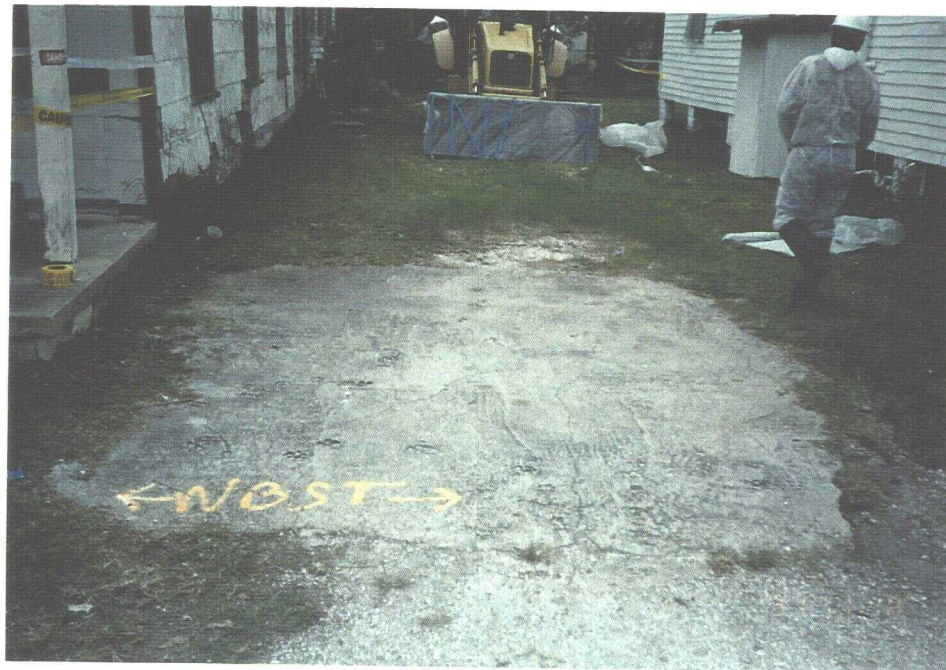
ACM Material

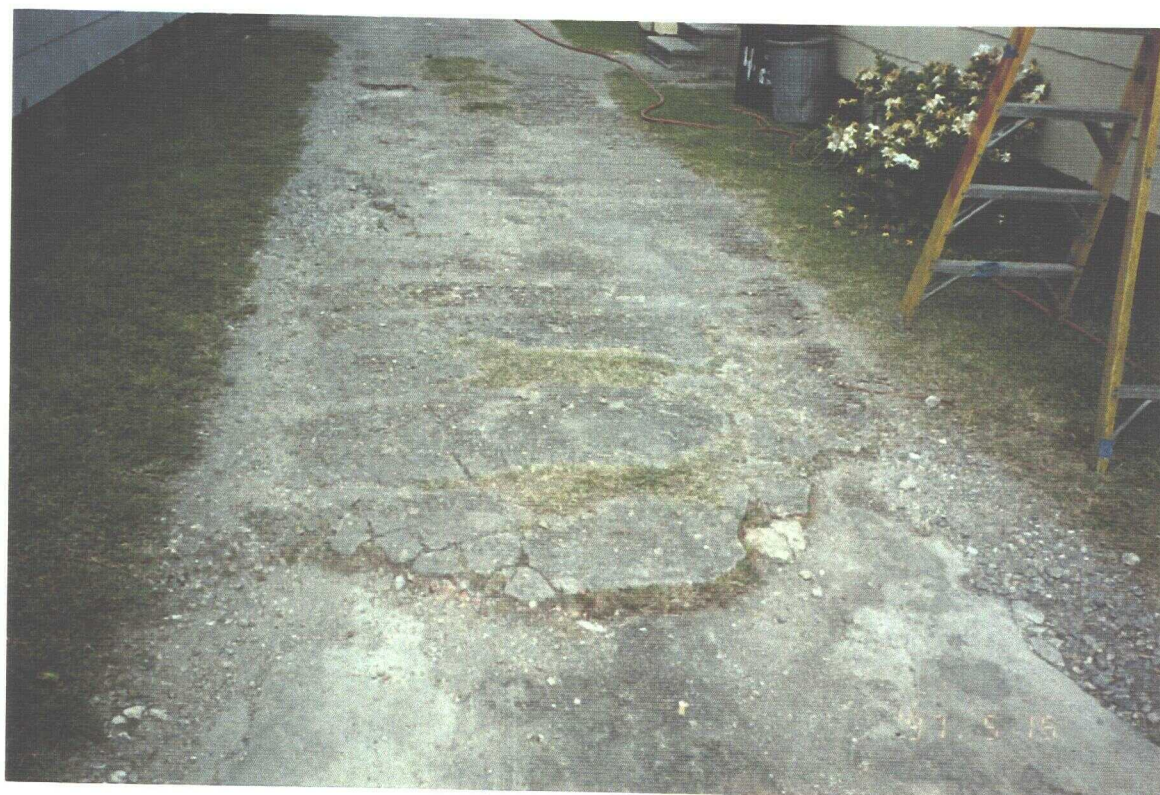
ACM Driveway

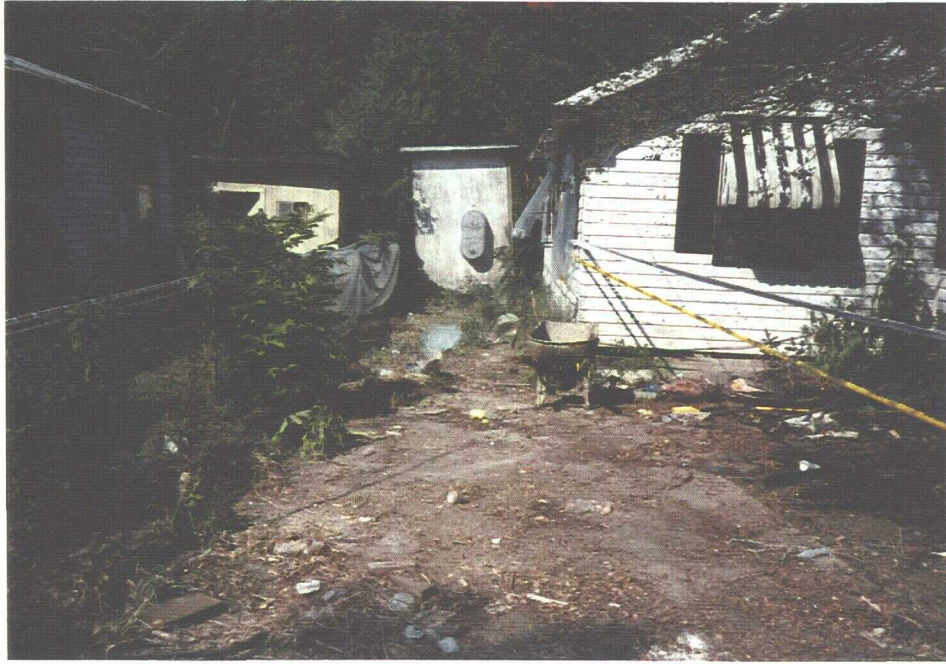
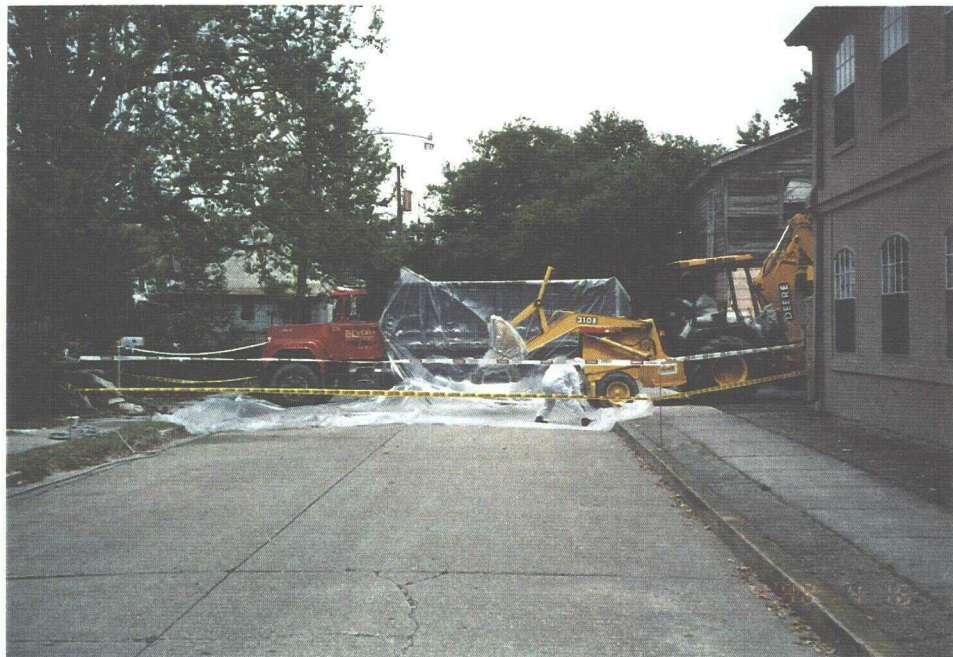
Site Preparation

Prior to the removal of the ACM beginning at each site, the area was isolated to restrict access for everyone except those performing the work. Caution tape was placed around the general area and asbestos tape was used to delineate the exclusion zone where only those wearing the proper personal protective clothing (PPE) were permitted to enter. Consideration of the best layout for the loading of the truck to transport the ACM was taken into account when preparing the site. In areas where the depth of excavation was adjacent to walkways or locations determined to be close to public traffic, orange construction fencing was placed to prevent access. If required, wooden walkways were placed to permit the resident to access his property during the excavation and restoration phases of the work. Critical barriers were placed over windows and air conditioning units if they were immediately adjacent to the work.

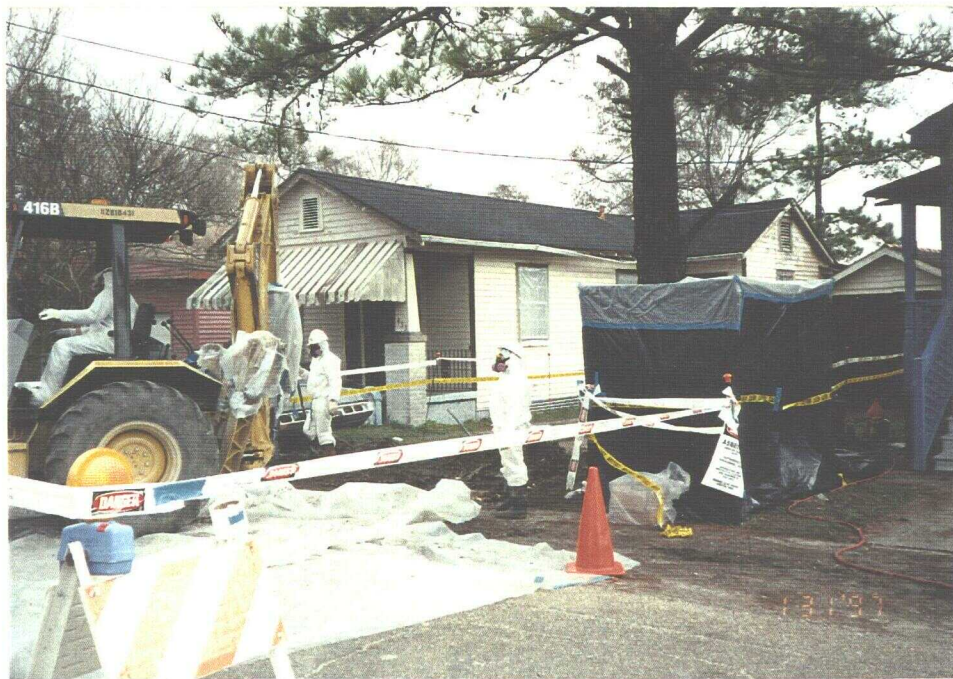
Temporary Decontamination/Change Room

A temporary decontamination/change room was constructed at the perimeter of the exclusion zone to permit the workers a place to change into and out of their PPE. This was constructed of steel rebar and black polyethylene sheeting. Any time a worker entered or exited the exclusion zone, he was required to pass through this area.

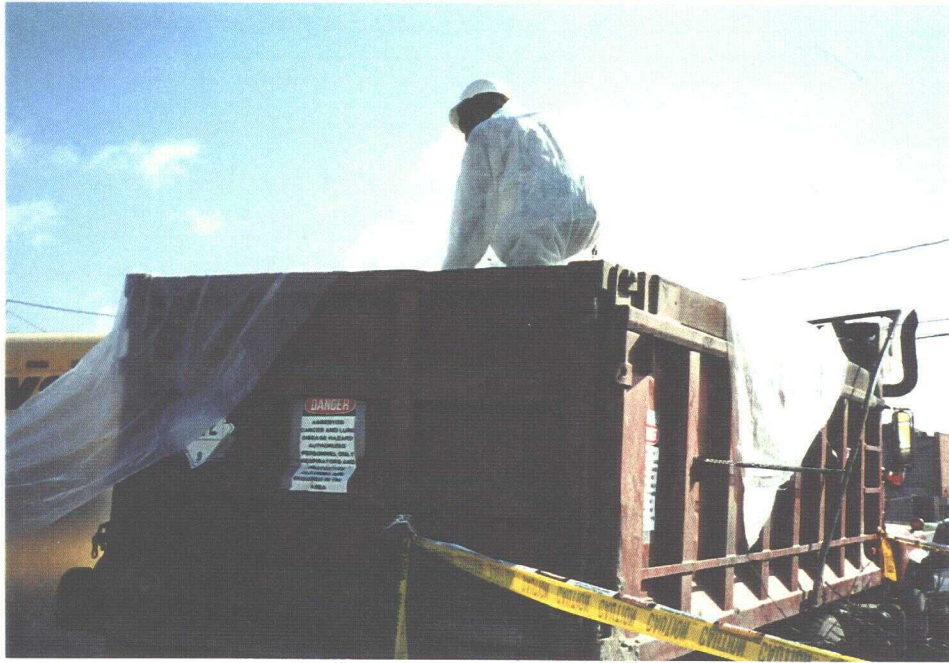
Placing Truck Liner

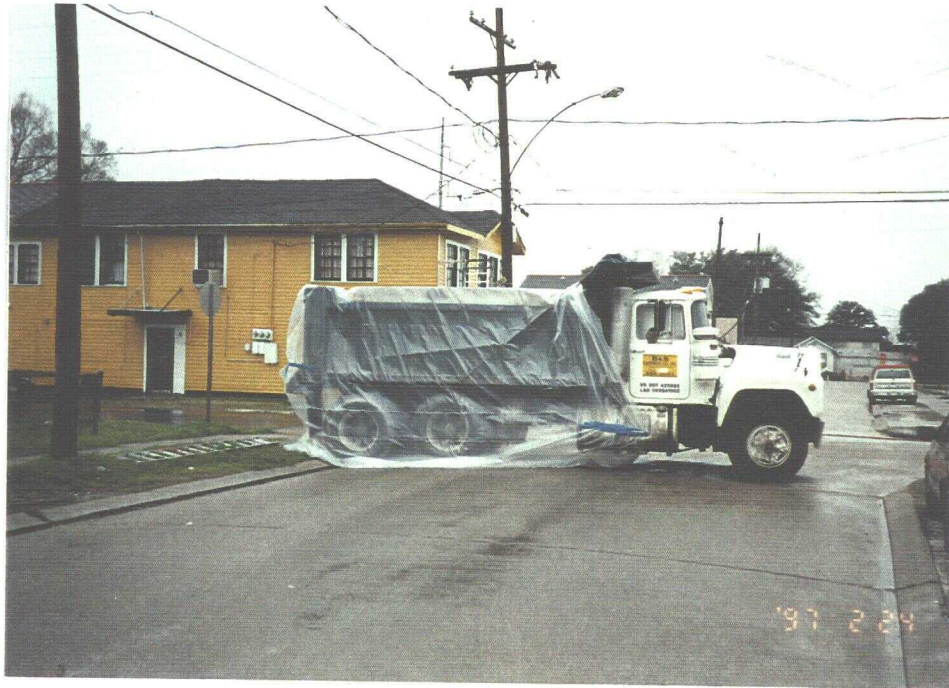
Truck Liner Preparation

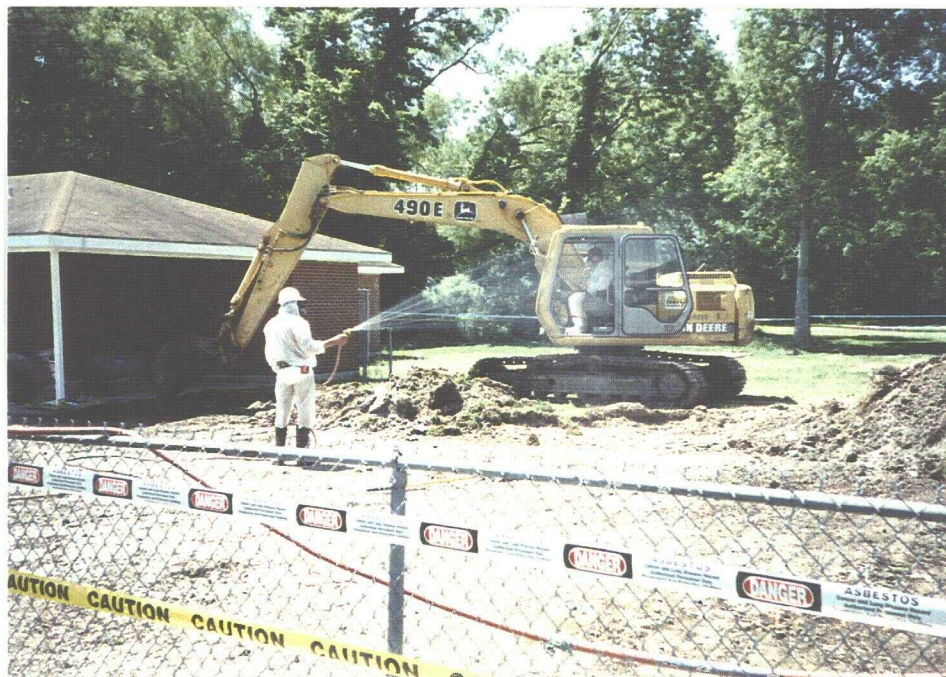
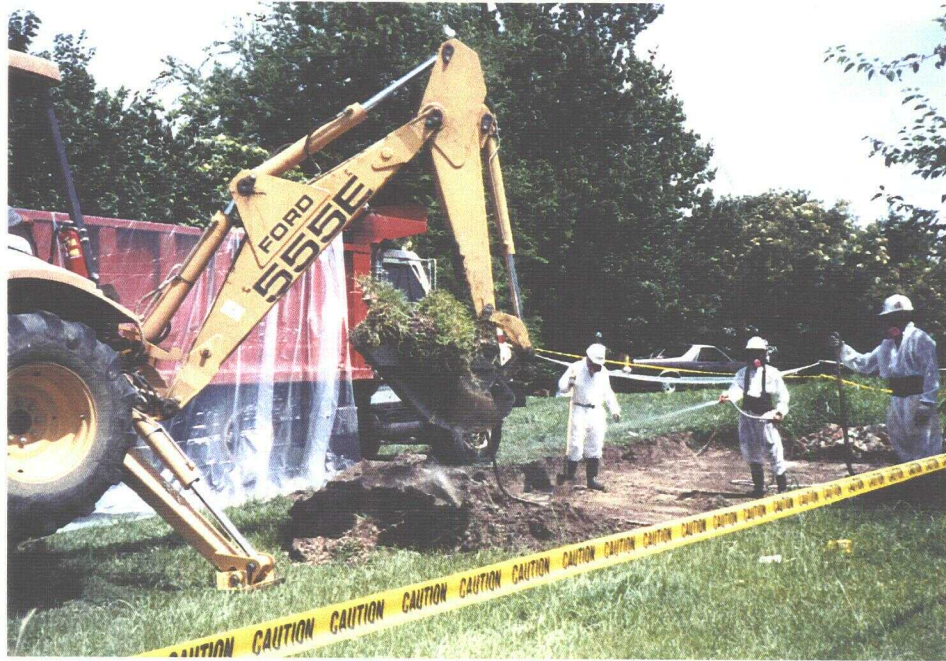
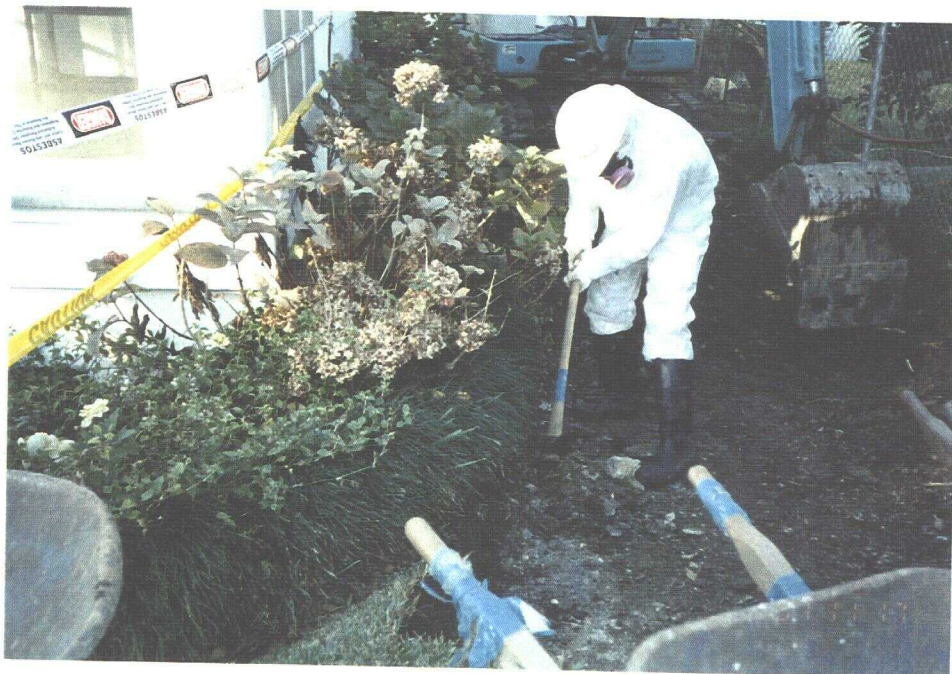
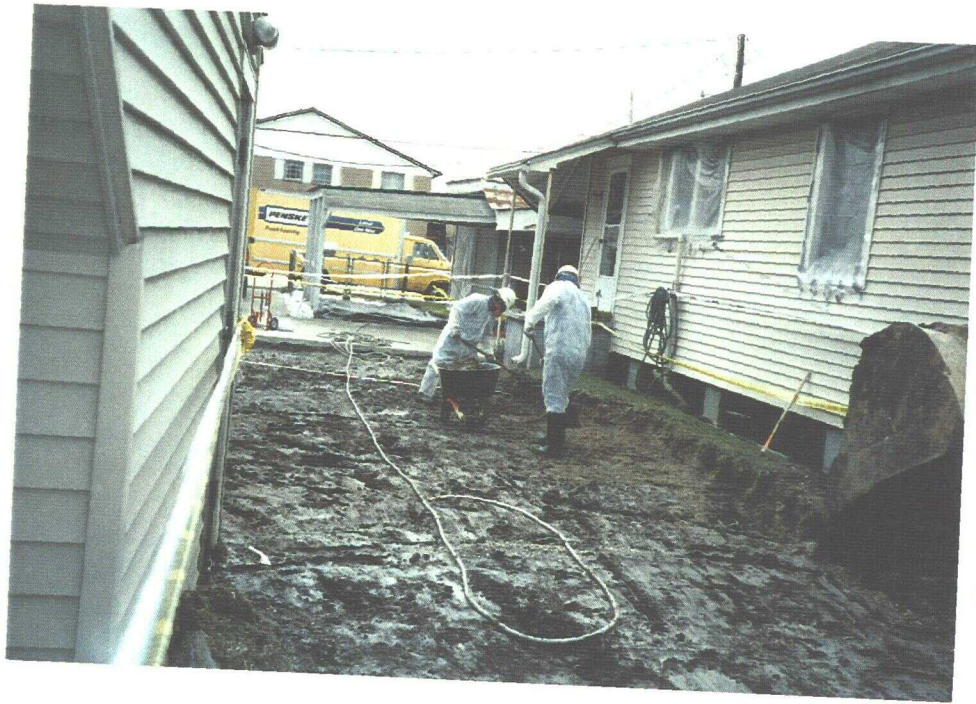
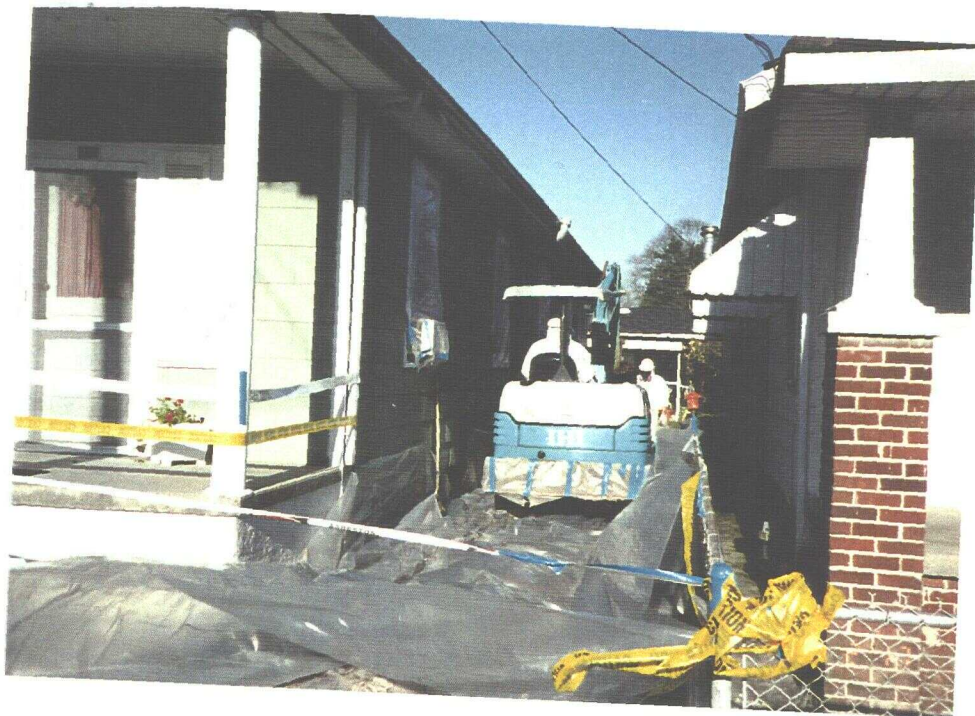
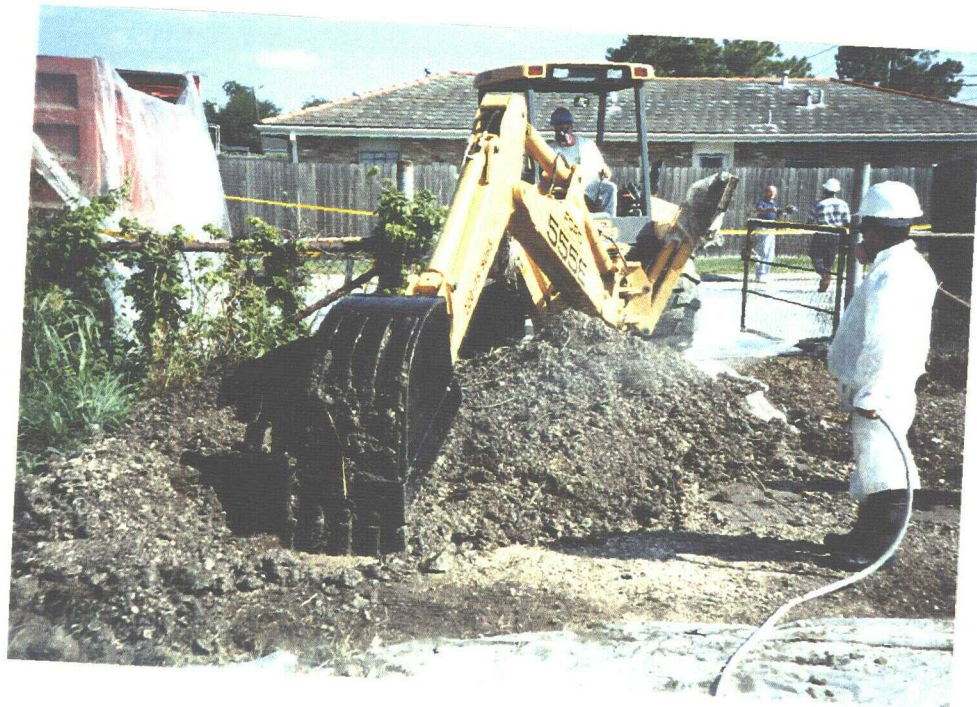
ACM Removal

The ACM was generally removed using a combination of backhoes, picks, jackhammers, wheel barrows and small hand tools such as concrete cutting equipment. The crews consisted of a LDEQ qualified supervisor, an equipment operator, and three to six field technicians depending on the site. The material was removed and placed in the backhoe bucket for placement into a nearby dump truck. The size of the truck also varied with the size of the site being excavated. At some of the larger properties, an excavator was used to remove the ACM. On large confined areas, a small bobcat type excavator was used.

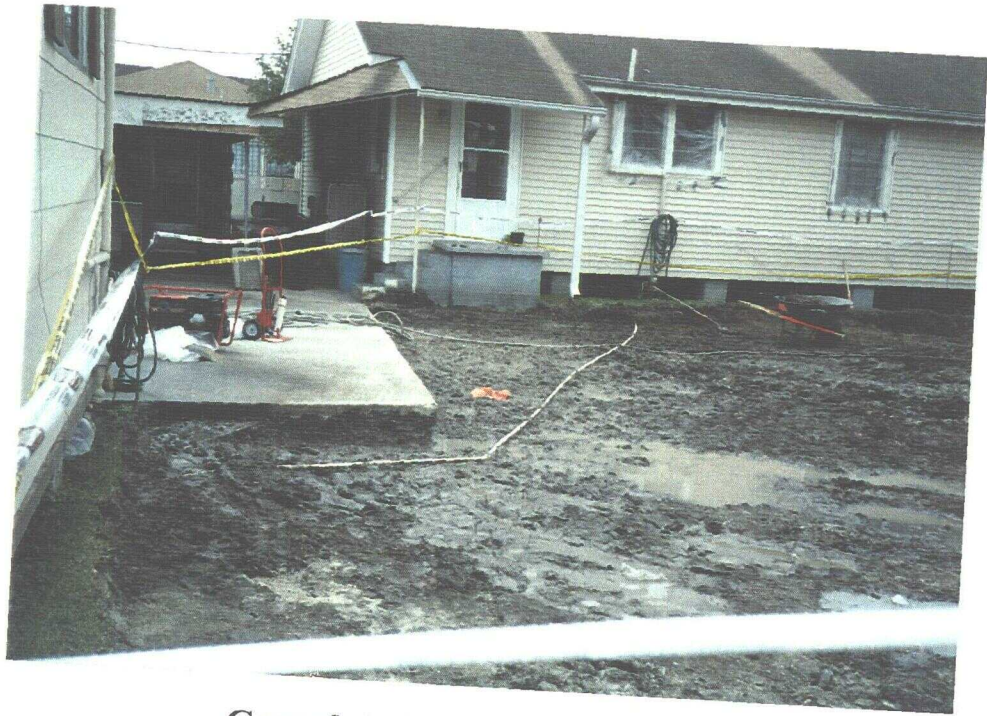
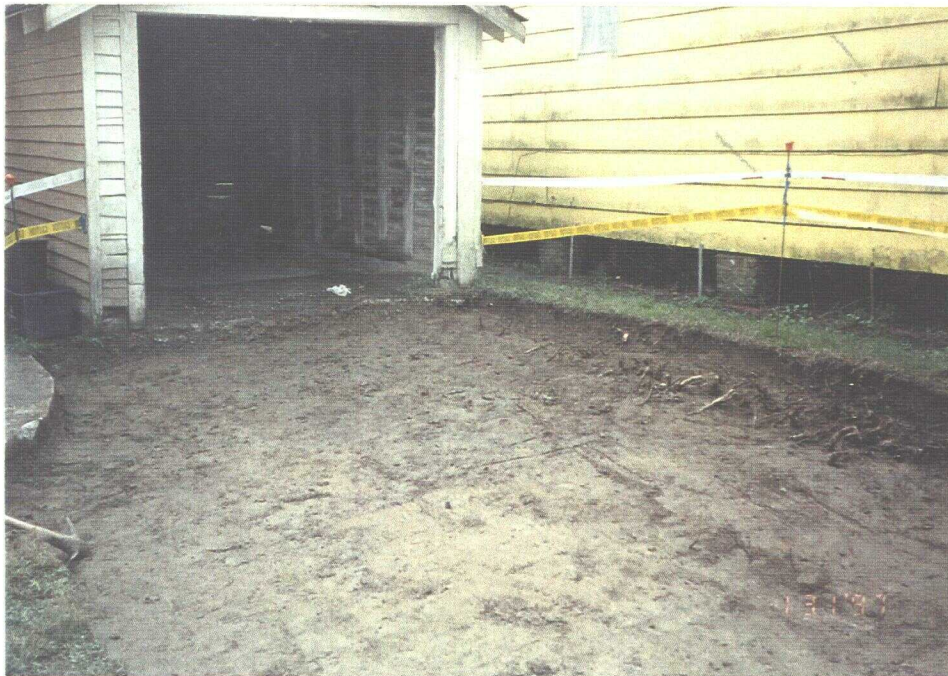
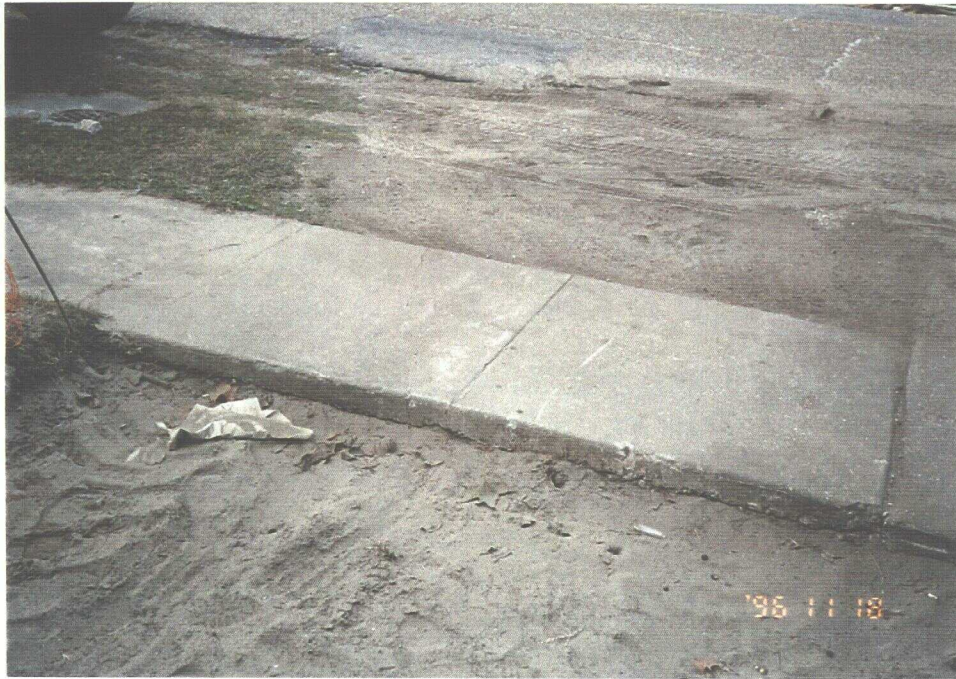
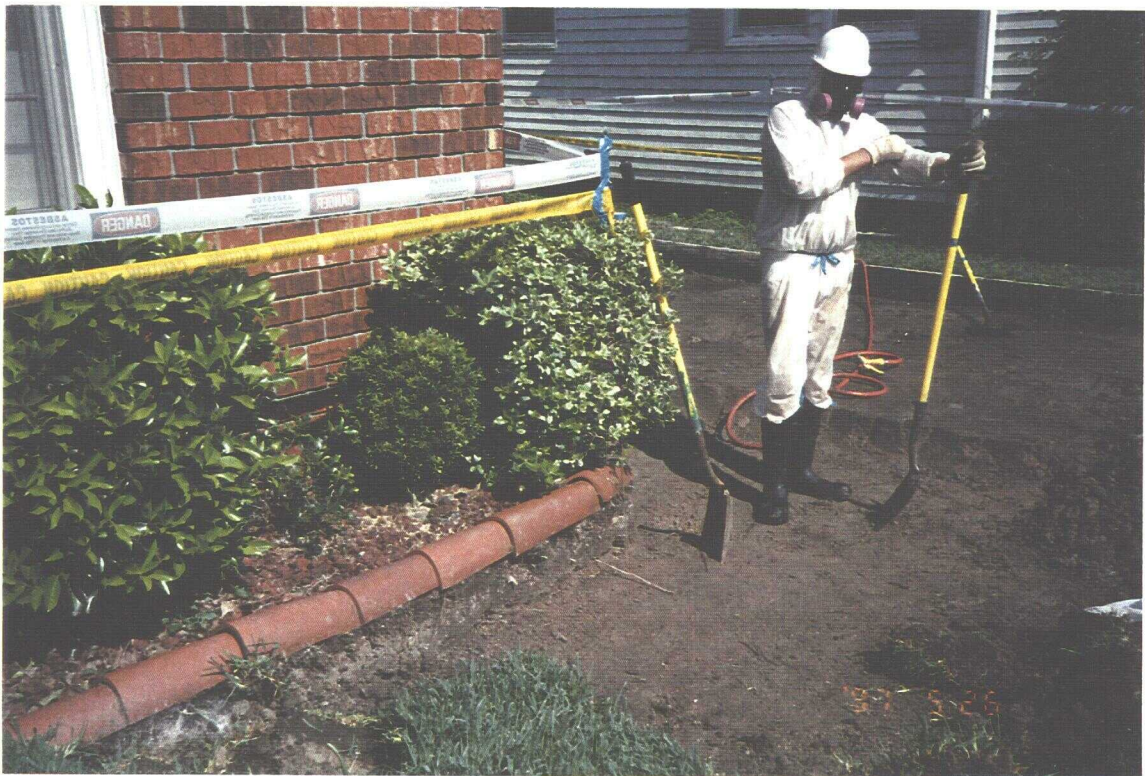
Completed ACM Removal

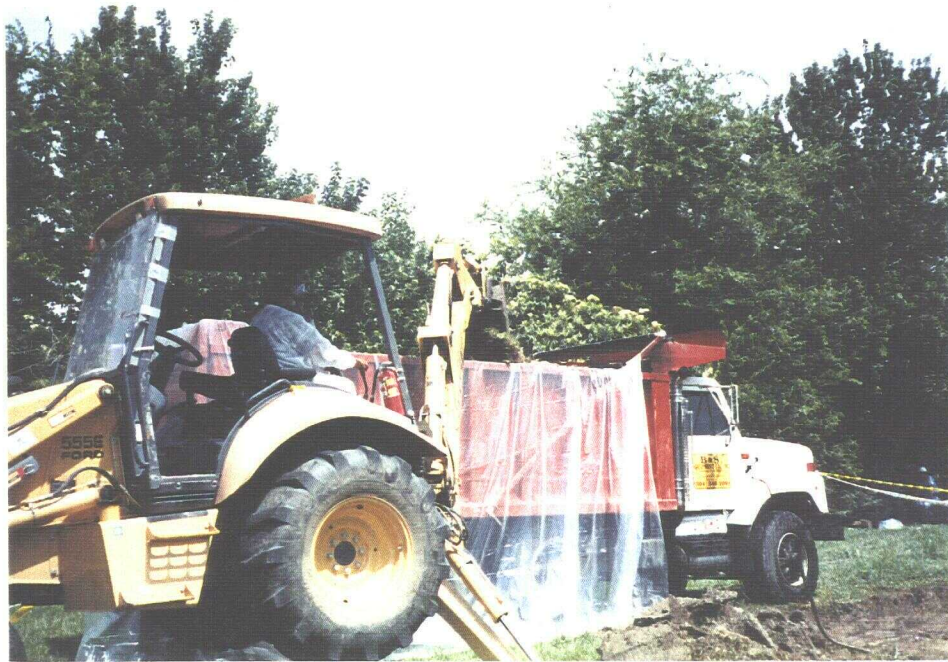
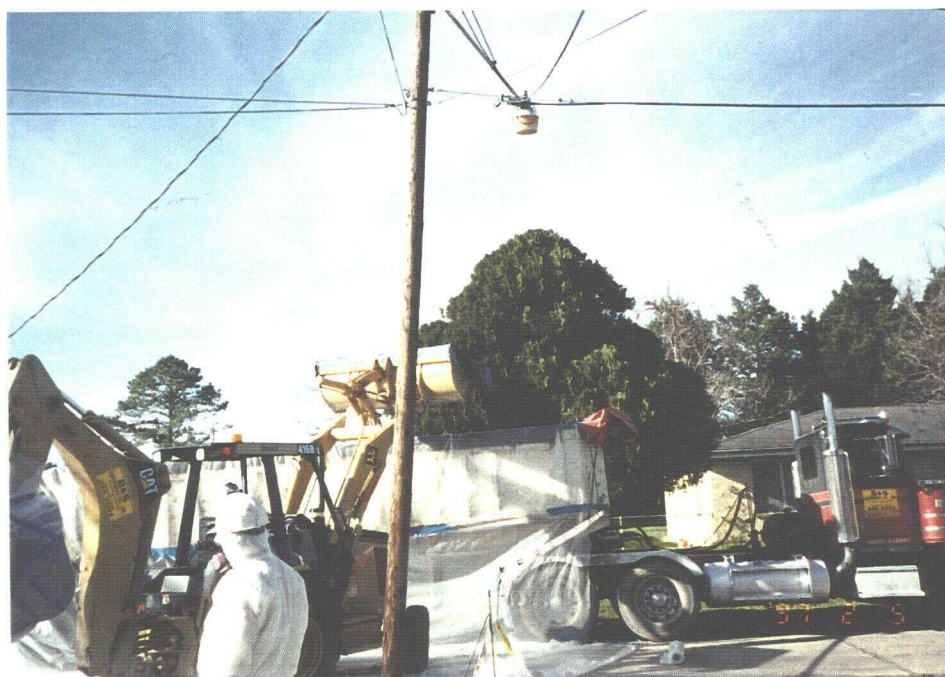
Loading ACM into Truck

As the ACM material was removed from each site, the material was placed in subcontracted trucks for transport to the Jefferson Parish Landfill for disposal. This landfill, operated by Waste Management, was an approved asbestos landfill by the LDEQ and obtained a CERCLA approval in conjunction with this project .

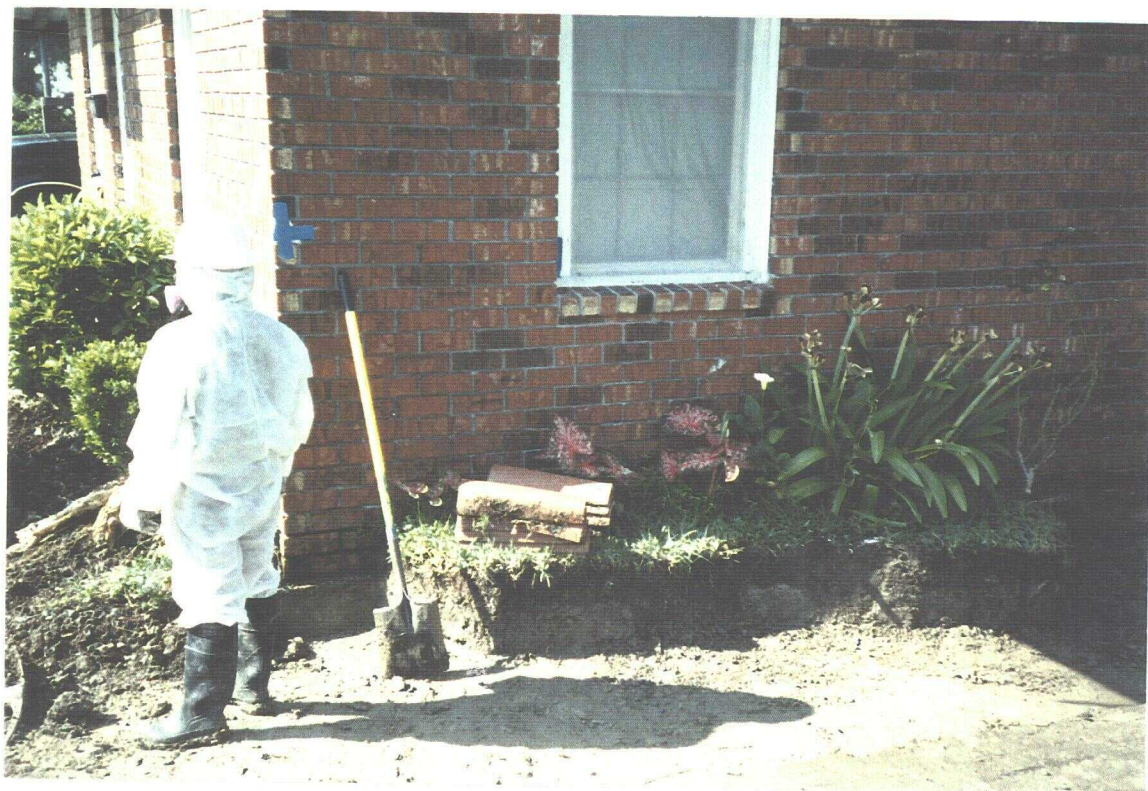
ACM Removal Adjacent to Home

During the excavation of the ACM, extreme care was taken to avoid damaging any existing utilities, pipelines, landscaping or any structure which may be nearby. In most cases, where any structures or appurtenances existed, such as fences and trees, the ACM was removed from around the structure without effecting the status of the structure. In the instances where a water line or gas line was damaged during the work, a local plumber was contacted to repair the damage as soon as possible.

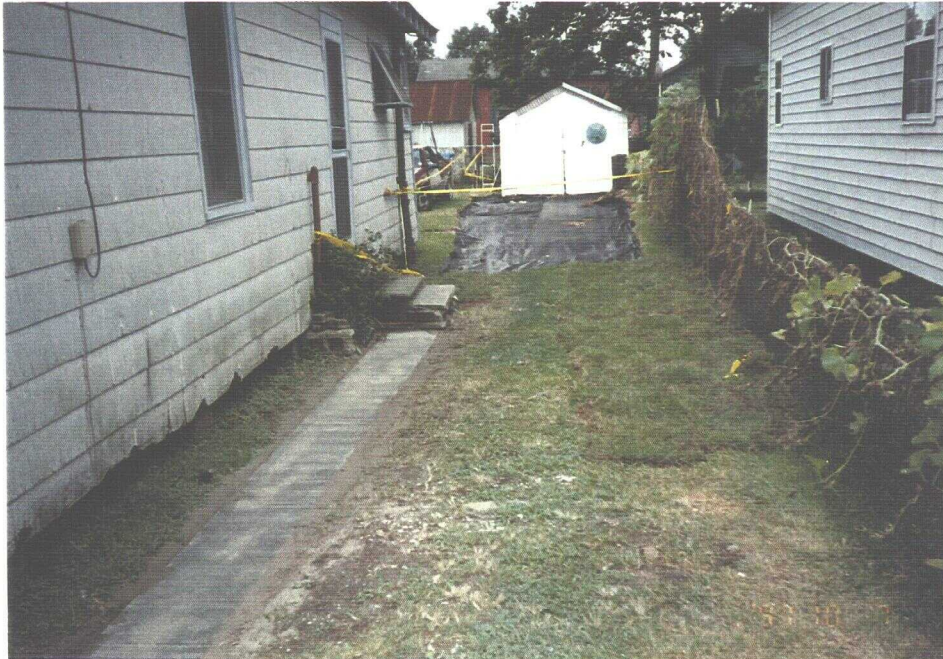
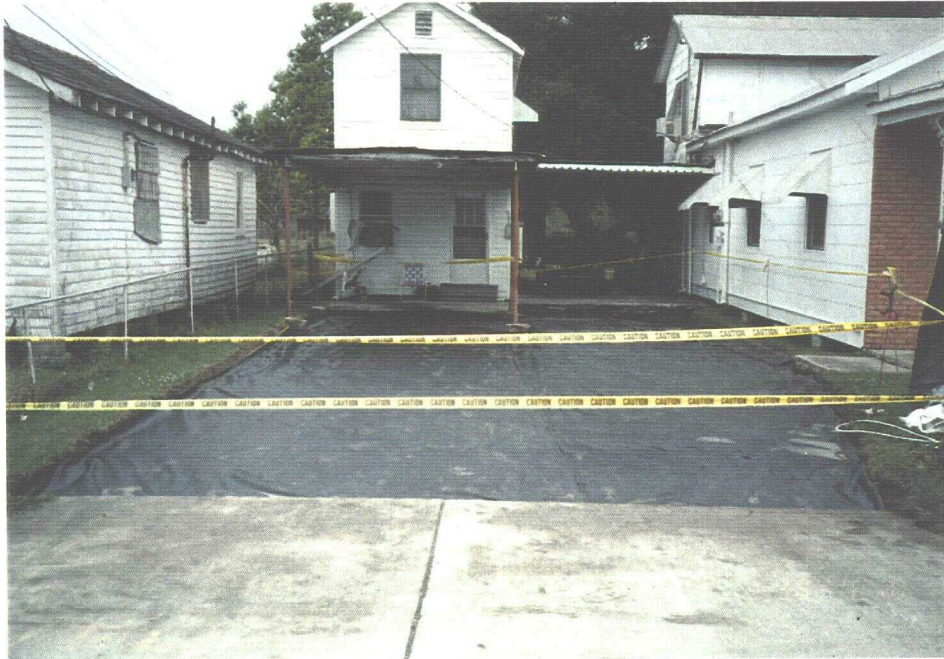
Completed Site with Geotextile

Once the start team inspection and sampling was complete, a 10 mil geotextile liner was placed in the excavated area to delineate the limits of the excavation. This geotextile was laid over the excavated area and anchored in place using large nails. The liner was placed to cover the entire area excavated as well as the sidewalls of the excavation.

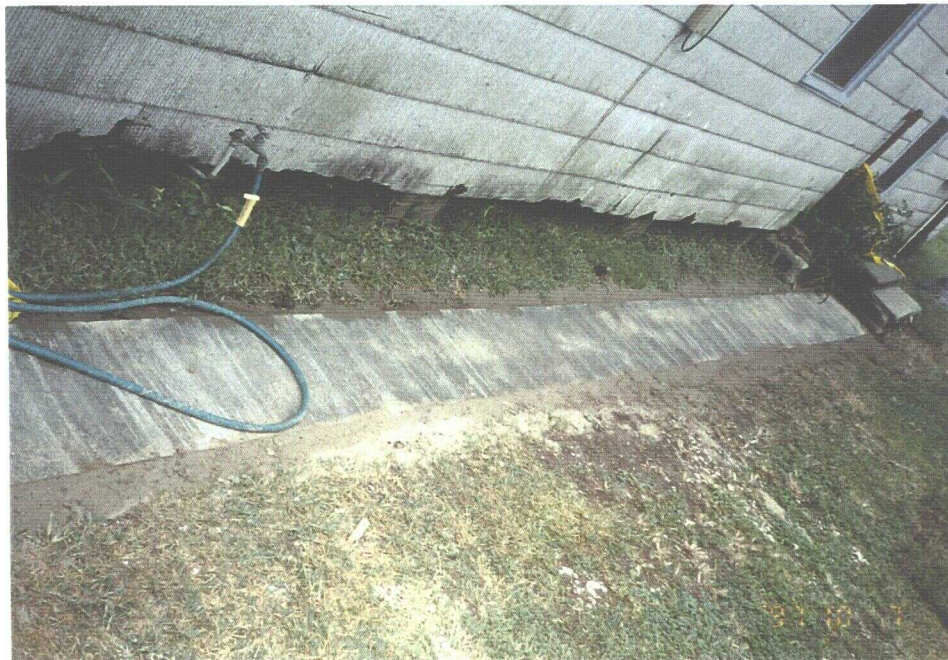
Concrete Walkway Restoration

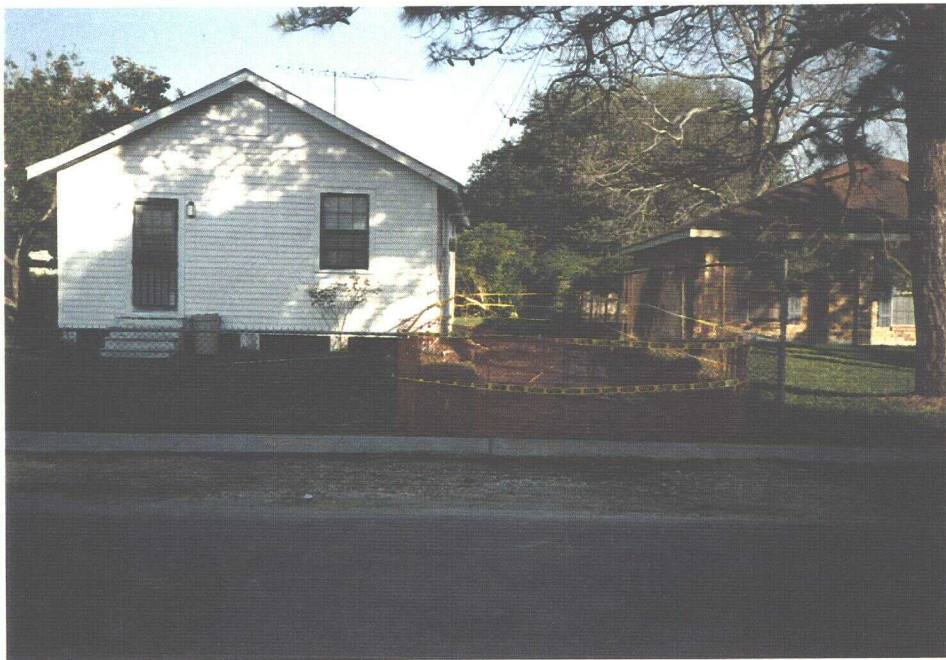
Completed Site with Geotextile and Fencing

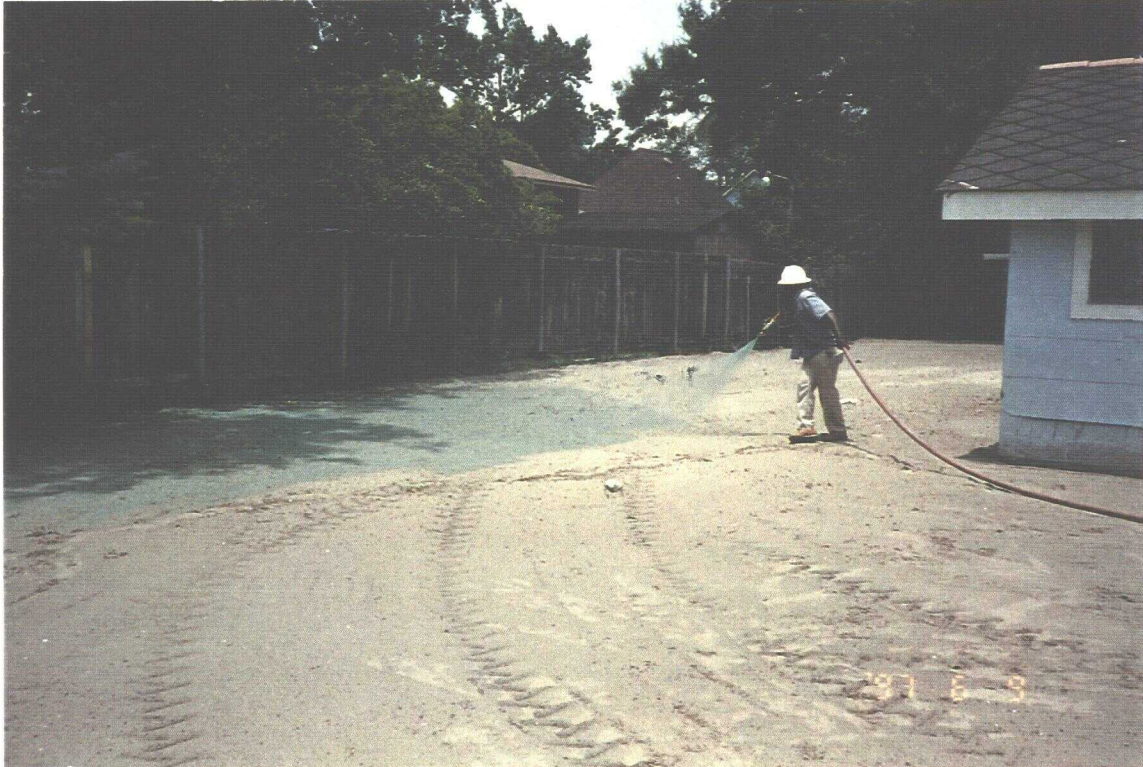
Hydromulching after Restoration
